FAILURE ANALYSIS OF PRESTRESSED CONCRETE STEEL BAR DURING THE INITIAL DRAWING PROCESS

Toni Agung Priambodo*^{1,2}, Apriardi Ihlis²

¹Material Science and Engineering Research Group, Faculty of Mechanical and Aerospace Engineering, Institut Teknologi Bandung, Jl. Ganesha 10, Bandung 40132, Indonesia

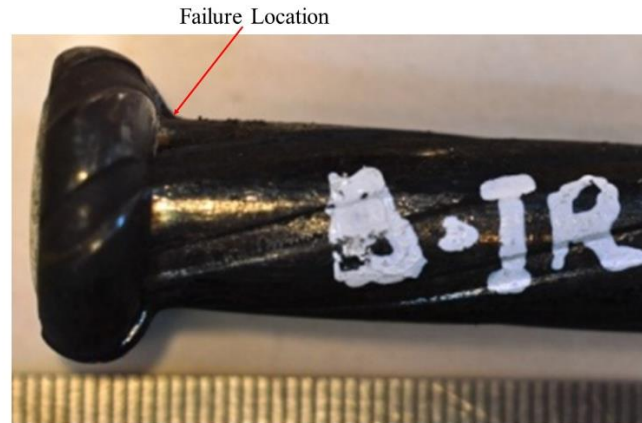
Figure 2. Failure Location

This paper reports the investigation of the failure of PC bar during the initial drawing process. By understanding the root cause, the similar failure would not occur. Figure 2 shows the failure located in the head section area.

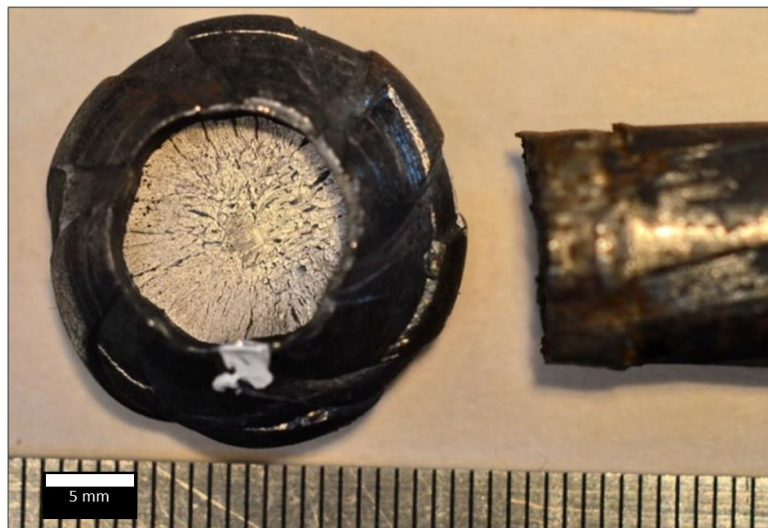
Figure 5. Cross Section of the Fractured Area

The fracture that occurs as shown in Figure 4 shows almost no change in dimensions in the fault area. This indicates a sudden brittle failure without allowing the steel to go through the plastic deformation and elongation stage [12, 13]. Figure 5 shows a relatively small radius in the head area that can lead to stress concentrations that can contribute to brittle fracture. Unlike a ductile fracture, a brittle fracture is a condition in which the material has low toughness. The ability to absorb energy due to external forces should be indicated by the occurrence of plastic

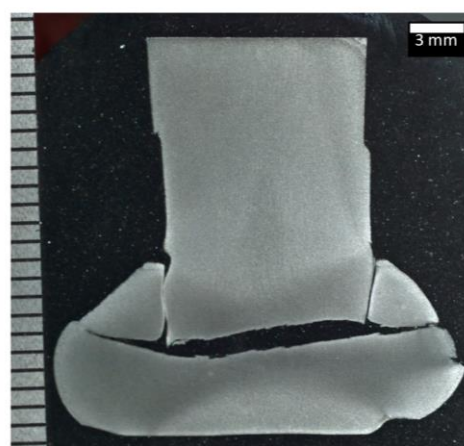
Figure 4. Fractured PC Bar at the Head Area

deformation but does not occur in brittle fractures.

Failure of the PC bar material during the prestressed concrete manufacturing process that occurred during the pretension process in the head section area showed a brittle fracture. This brittle fracture was caused by the tempering process conducted at an inappropriate temperature, causing temper embrittlement. The bulging part in the PC bar head section area becomes an area with the highest stress concentration so the brittle fracture occurs in that area. To avoid the occurrence of similar types of failures, the tempering process at an inappropriate temperature 370 °C - 575 °C should be avoided.
